Opflow

Fire and Ice

Tame Temperature Extremes in Water Tanks

A Maine utility is learning to cope with storage tank stratification caused by widely varying seasonal temperatures.

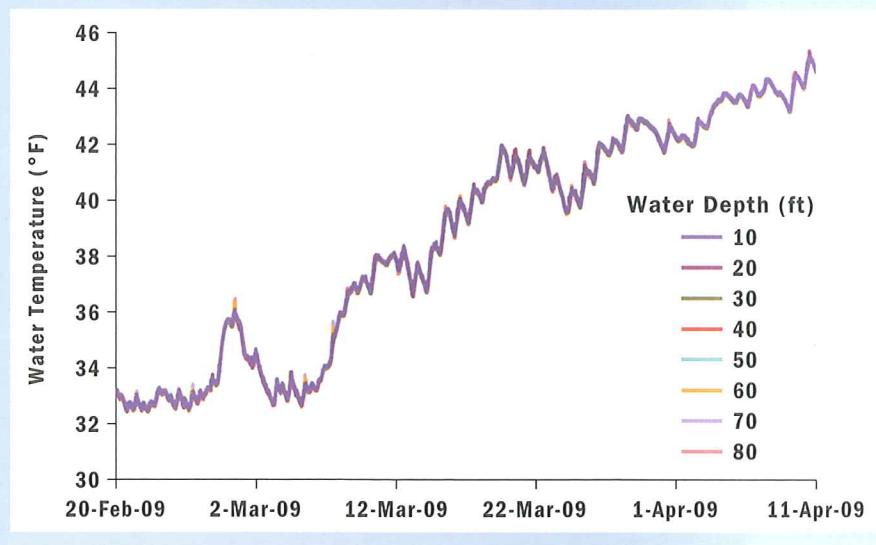
Figure 2. Temperature Changes in Tank

Spring brought an increase in average temperature and longer periods of sunlight, both of which increased the mixed tank's average temperature.

Average temperature in the standpipe rose each day, but no thermal stratification was observed (Figure 2, page 21). As a result, water temperature at the top of the tank was much lower than the temperature in the unmixed tank. Because chlorine residual evaporation occurs faster at higher temperatures, team members surmised that overall disinfectant residual losses would be less in a well-mixed tank. Testing at the top of the mixed tank confirmed residuals as high as 0.7 mg/L. Water at the top of the unmixed tank remained depleted of chlorine.

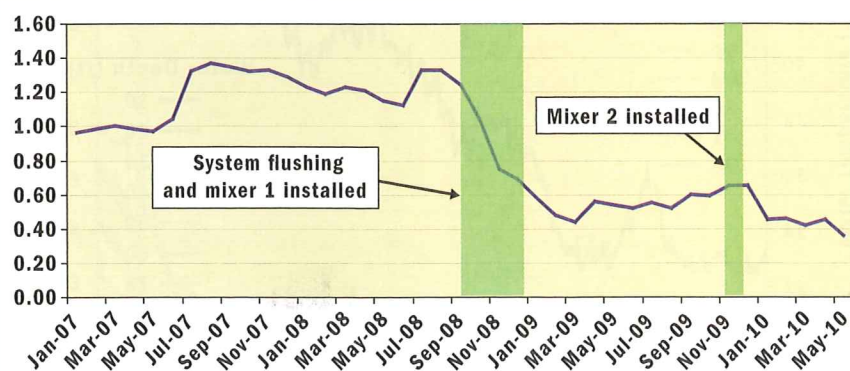
Figure 3. Average Residual Loss in Distribution System (mg/L)

Overall disinfectant residual demand in the distribution system decreased substantially after mixers were installed.

Measurements of residual leaving the plant and in 10 sites in the distribution system show a substantial decrease in overall disinfectant residual demand after mixers were installed (Figure 3). Before the mixers, roughly 1.2 mg/L of

disinfectant residual was consumed in the distribution system (i.e., concentration leaving the plant minus the average concentration in the system). But after the mixers were installed, residual demand fell to around 0.4 mg/L. Operators estimate that this corresponds to a chlorine/day decrease of 22 lb for post-filter chlorination, saving about \$1,200/yr.
